## DETAILED REPORT

### Study of Causes & Impacts of the Uttarakhand Disaster on 7<sup>th</sup> February 2021 in Raunthi Gadhera, Rishiganga & Dhauliganga Valley: Measures to Reduce Disaster Risks

April 2022

**NATIONAL DISASTER MANAGEMENT AUTHORITY  
MINISTRY OF HOME AFFAIRS  
GOVERNMENT OF INDIA**

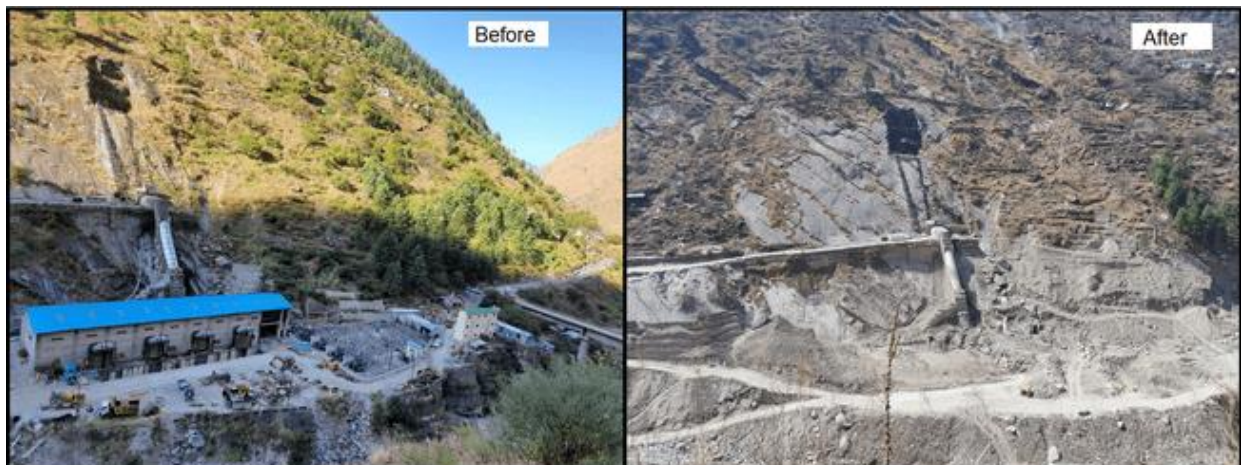
**Photo Plate 1:** Before and after images of the Rishiganga HEP

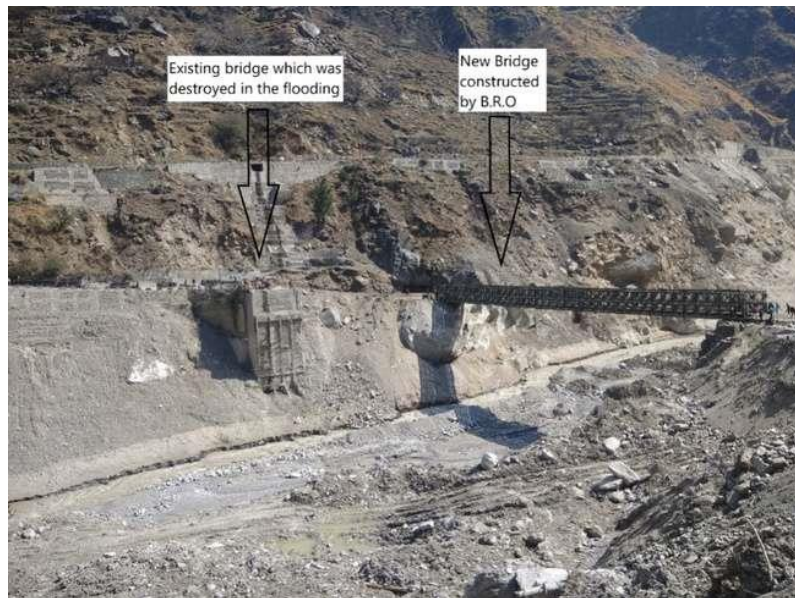
**Photo Plate 2:** Remnants of damage BRO motor bridge with bailley bridge constructed by BRO for vehicular movement on Joshimath – Malari road after the event

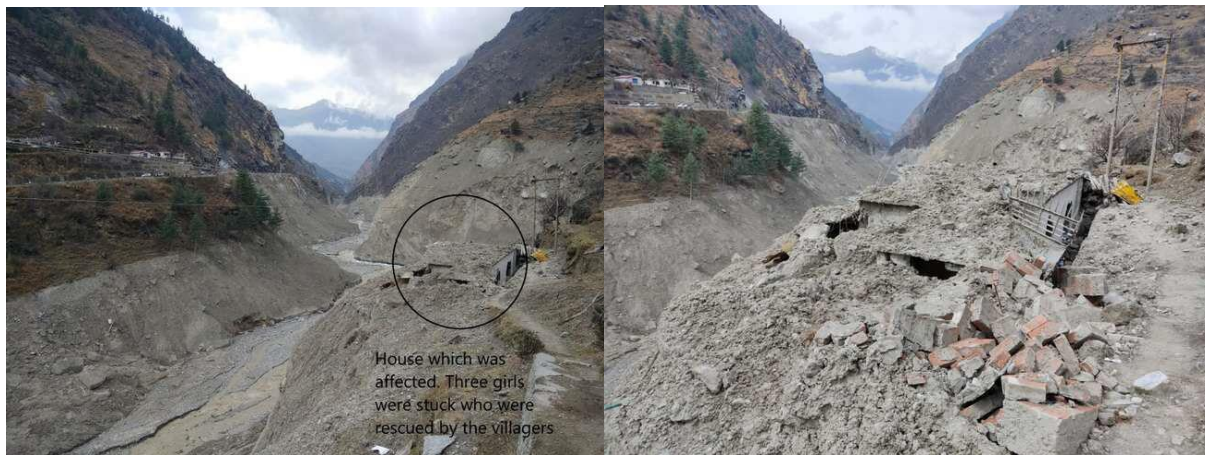
**Photo Plate 3:** House which was affected. Villagers rescued three girls who were stuck inside the house

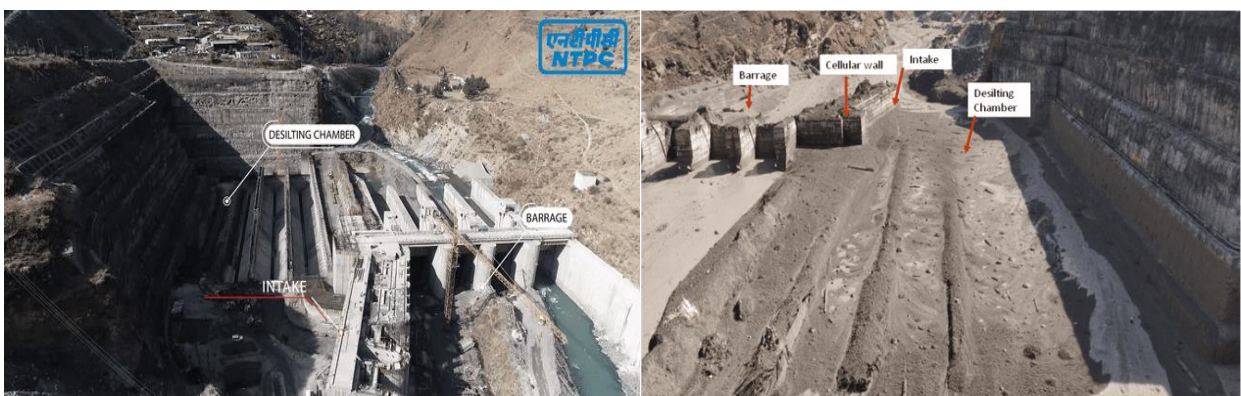
**Photo Plate 4:** Before & after image of NTPC Tapovan-Vishnugad HEP

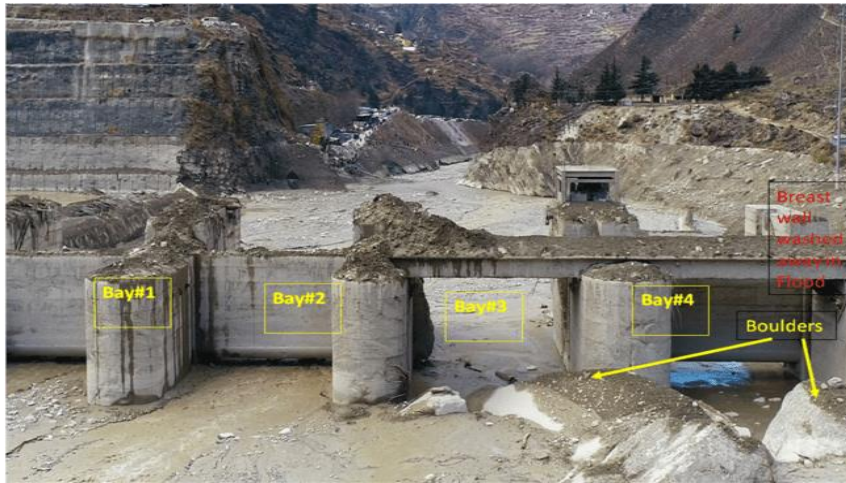
**Photo Plate 5:** Damaged barrage of NTPC Tapovan-Vishnugad HEP

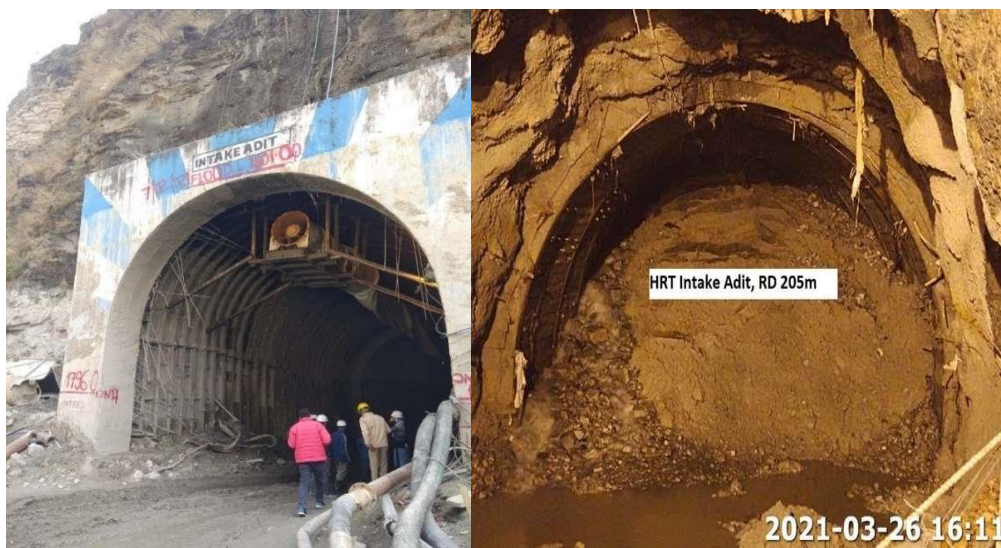
**Photo Plate 6:** Outside of the intake Adit tunnel with HFL of 1801 m with submerged inside of the HRT intake adit

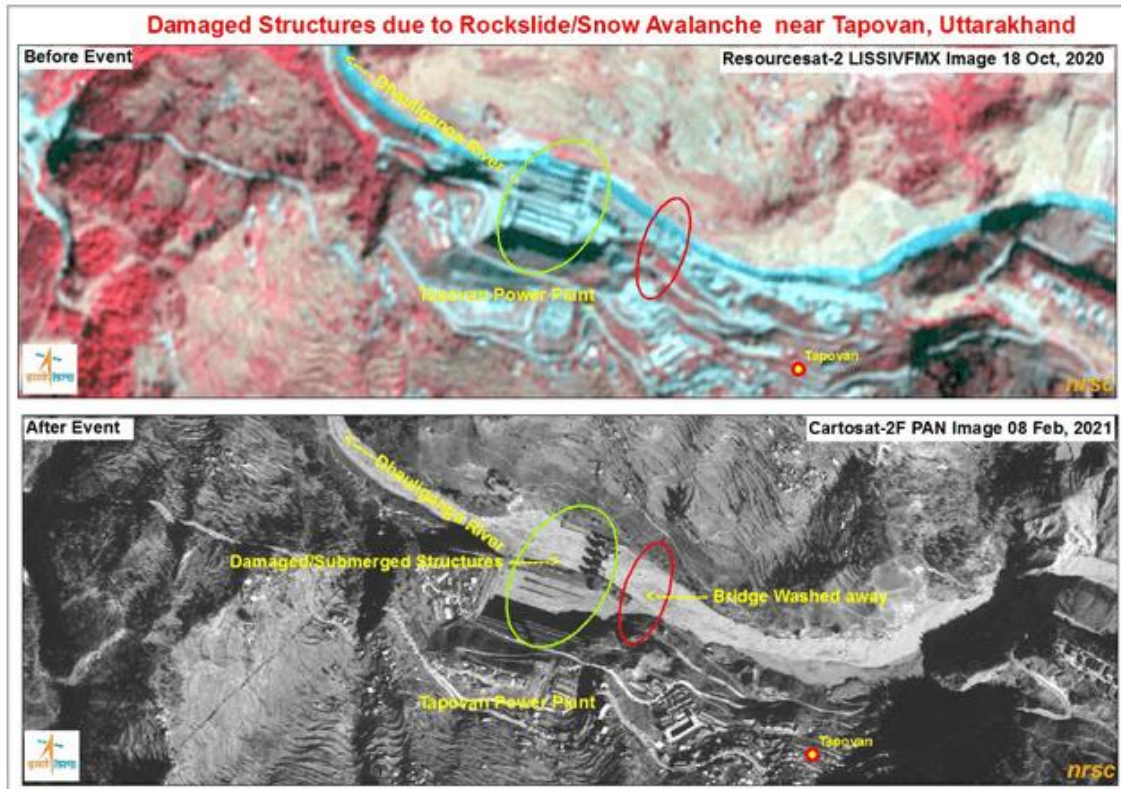
The impact of the disaster on the NTPC Tapovan plant, which has suffered significant damages to infrastructure is highlighted in Green and Red ellipses are depicted in Figure 11. The Green colour highlights the damages to the barrage and desilting tanks which were submerged in the thick slush and the Red colour highlights the bridge washed away in the deluge.

**Figure 11:** Damage to NTPC Tapovan as viewed from Indian Remote Sensing Satellites  
(Source: NRSC-ISRO)

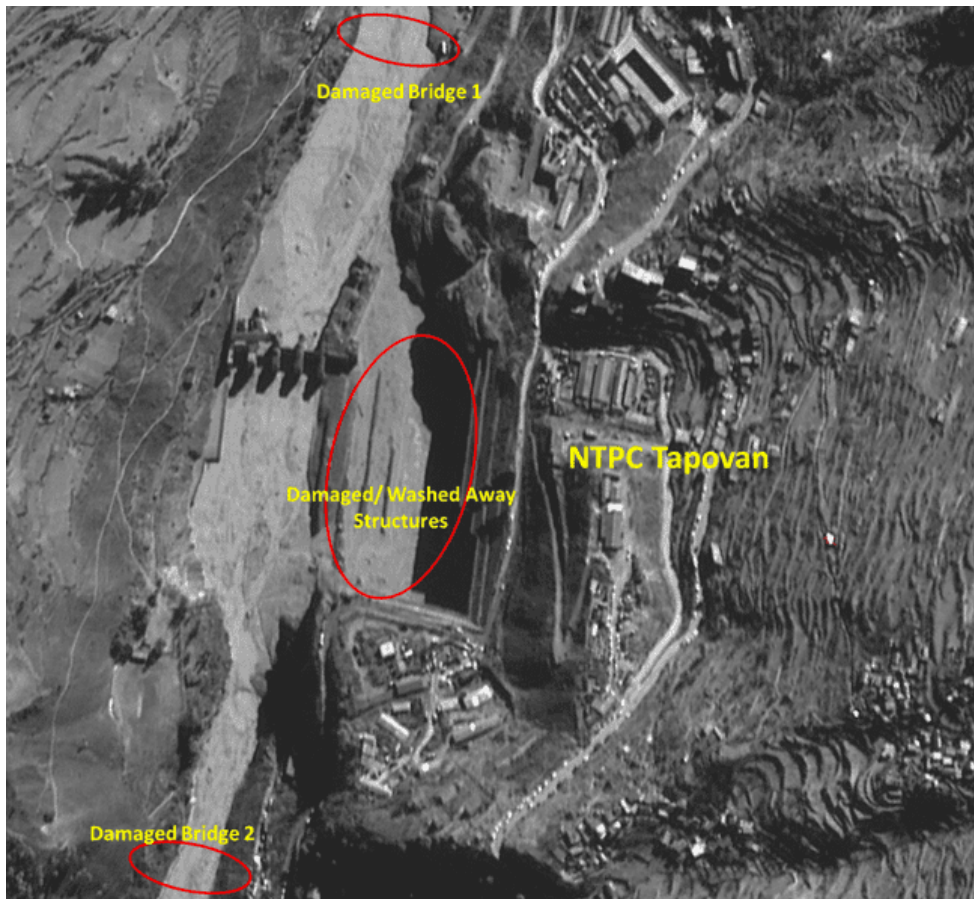
1. Damage to NTPC sluice structures due to sediment deposits is visible
2. Damage to the service lanes on either side of the river Dhauliganga
3. Extensive deposits of sediment are seen in the river channel
4. Bridge before the dam has been washed out

**Figure 12:** Zoomed view of Tapovan plant as viewed by Cartosat2 series on 9<sup>th</sup> February 2021  
(Source: NRSC-ISRO)

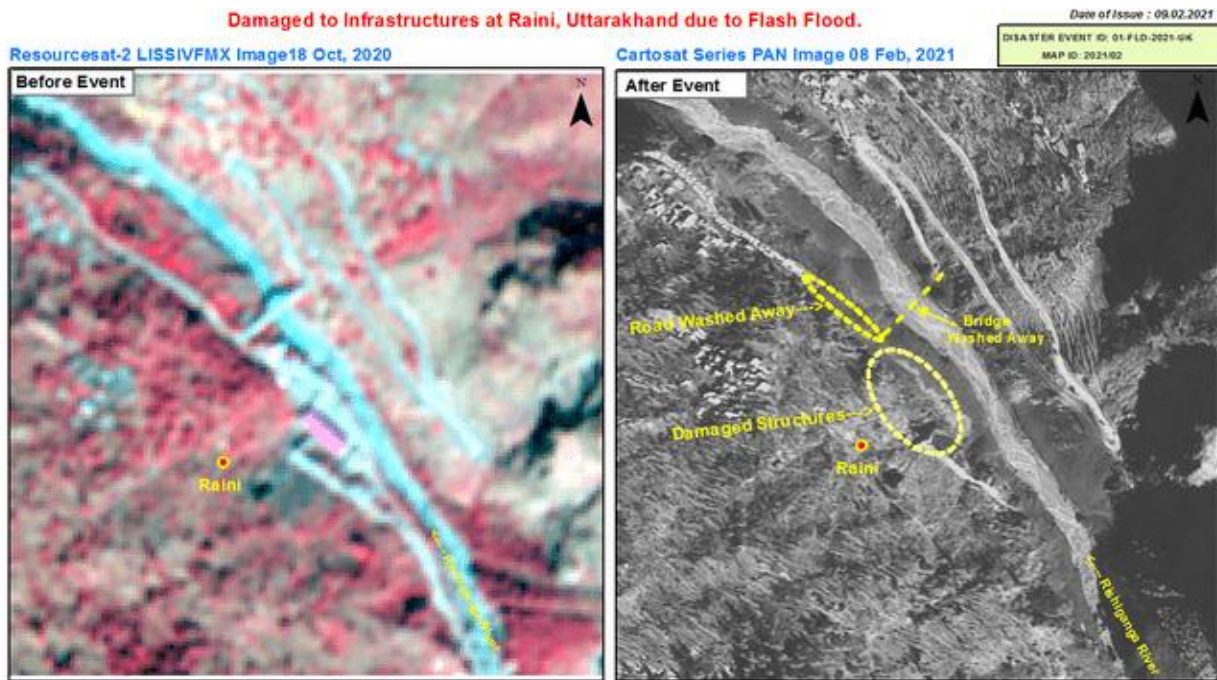
During the field visit on 26<sup>th</sup> and 27<sup>th</sup> March 2021, it was observed that huge boulders and sediment deposits to the tune of more than 20 meters were deposited and washed away the 13.5 MW Rishiganga power house.

**Figure 13:** Infrastructure damage at Raini Village (CARTOSAT 2F on 8<sup>th</sup> February 2021) (Source: NRSC-ISRO)

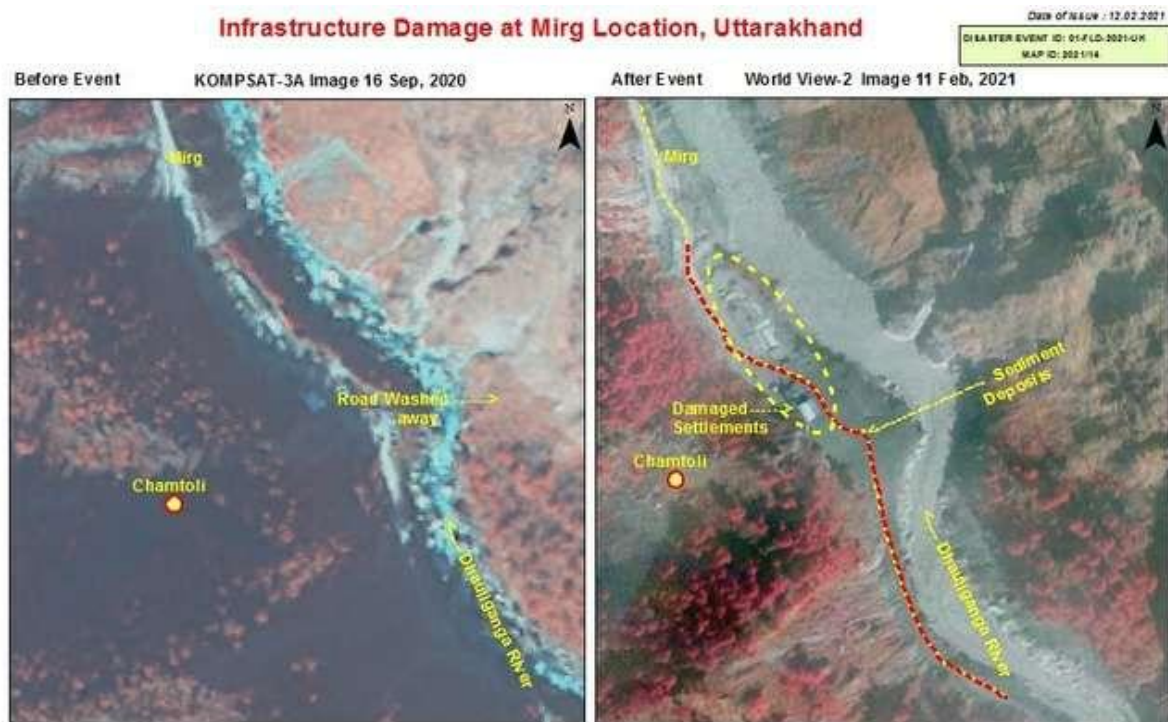
**Figure 14:** Damages to infrastructure in Mirg as on 11<sup>th</sup> February 2021 (Source: NRSC-ISRO)

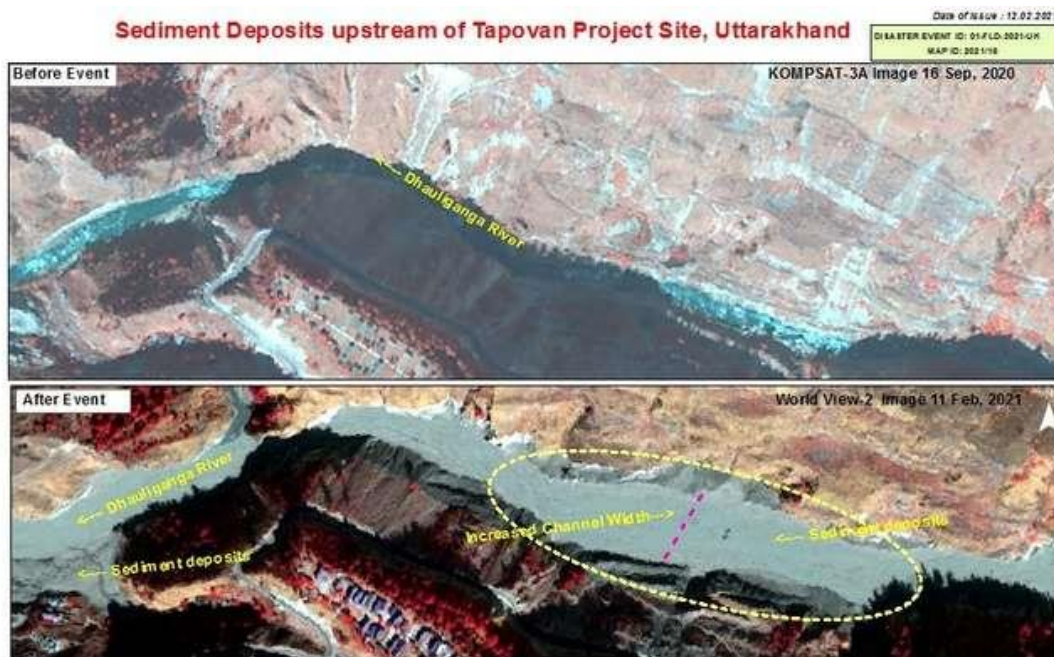
**Figure 15:** Damages to bridges and increased channel width in Tapovan Upstream  
(Source: NRSC-ISRO)

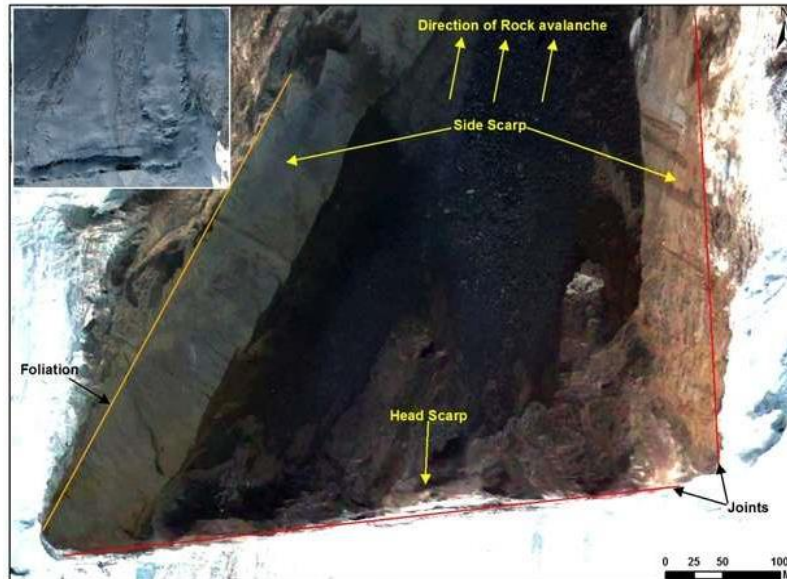
The main source of this disaster was a rock avalanche. The crown of the rock avalanche that triggered cascading effect in downstream areas, is located at 5474 m height and longitude 79° 43' 52.03" E and latitude 30° 22' 27.38" N. The rock failure near the crown is controlled by two joint planes (Joint1: Strike - N78°; dip = 79° and Joint2: Strike = N358°; dip = 62°) and one foliation plane (Strike = N28°; dip = 49°). The rock type at the crown is migmatite gneiss and marble bands (Source: Bhukosh, GSI). This geometrical disposition of joints and foliation has resulted in a wedge-type failure (Figure 16). The average height of the head scarp is 150 m and the length is 600 m. Head scarp and side scarps are visible in the Pleiades image. Fresh rocks and boulders are also clearly seen in the post-event Pleiades image. A layer of glacier ice-capped over the rock has also moved down along with the rocks. All joints along the avalanche travel path were mapped.

**Figure 16:** Post-failure Pleiades image showing the crown of the rock avalanche. Scarps exposed due to wedge-type failure along joint and foliation planes are seen. Inset shows pre-failure Komsat-3A image

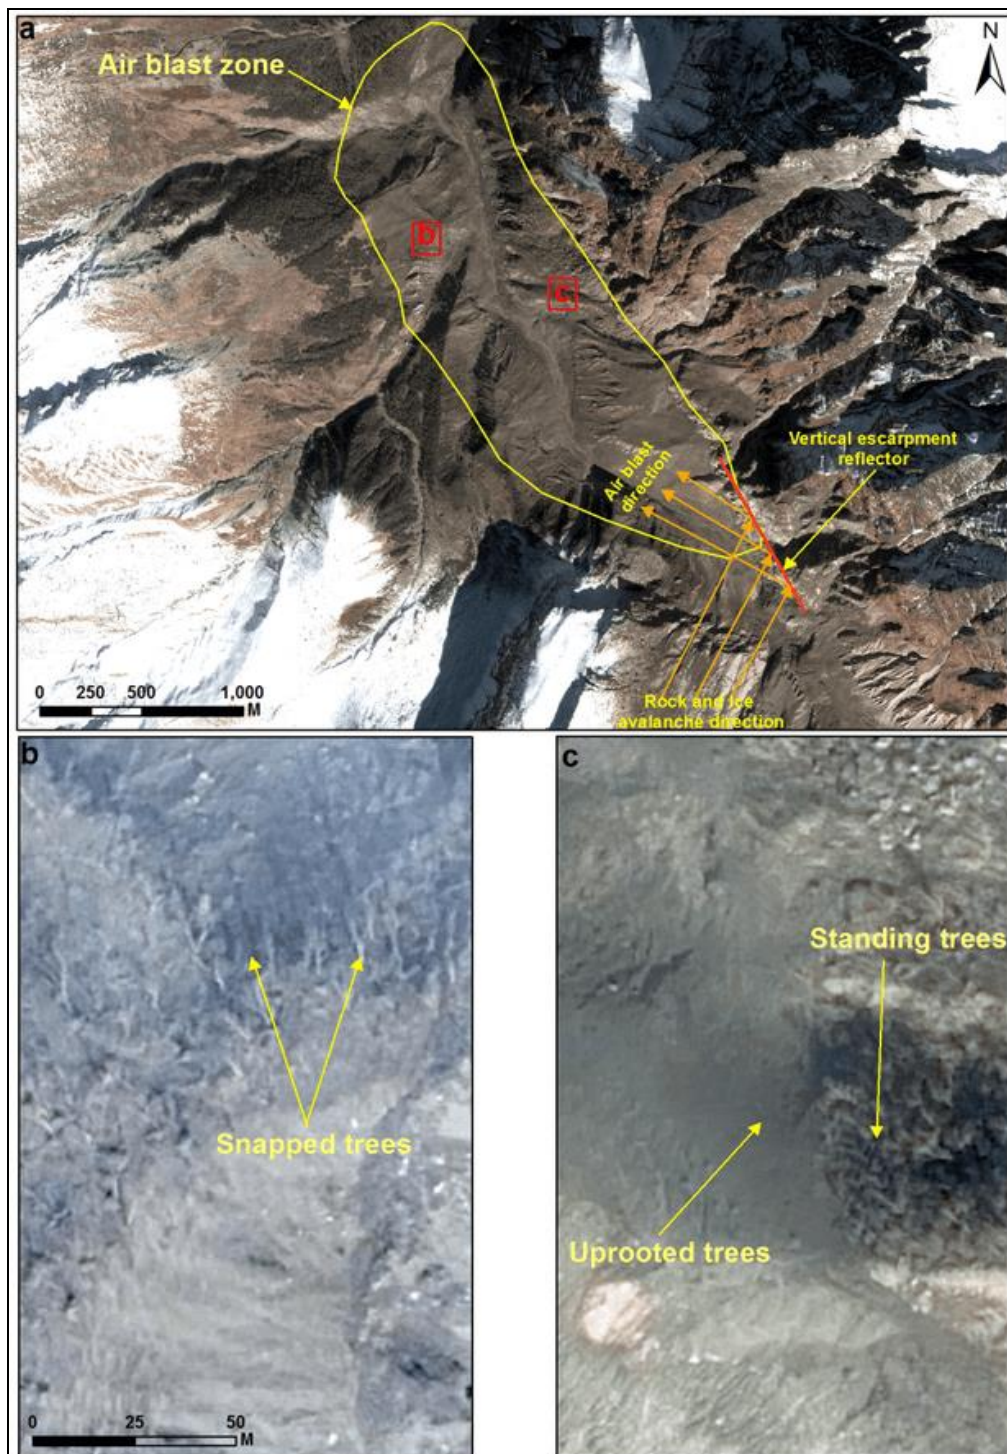
Air blast is an extreme rush of air loaded with projectiles capable of causing severe destruction (Penna et al., 2020). Air blast is one of the prominent after-effects of Rock avalanches. The rock and glacieret mass that has descended from the crown region hit a mountain escarpment on the opposite side of the valley. The escarpment has approx. 900 m length and 500 m height and it is oriented in NNW-SSW direction. This vertical escarpment acted as a reflector and siphoned the displaced air mass towards the valley (Figure 17). As a result of this air blast, trees were uprooted and snapped. The extent of damage to trees is seen upto 3.2 km from the zone of impact.

**Figure 17:** Air blast due to rock and ice avalanche. **a.** Air blast zone and direction illustrated on Post-event Pleiades image. **b.** Trees snapped, and **c.** Trees uprooted due to air blast

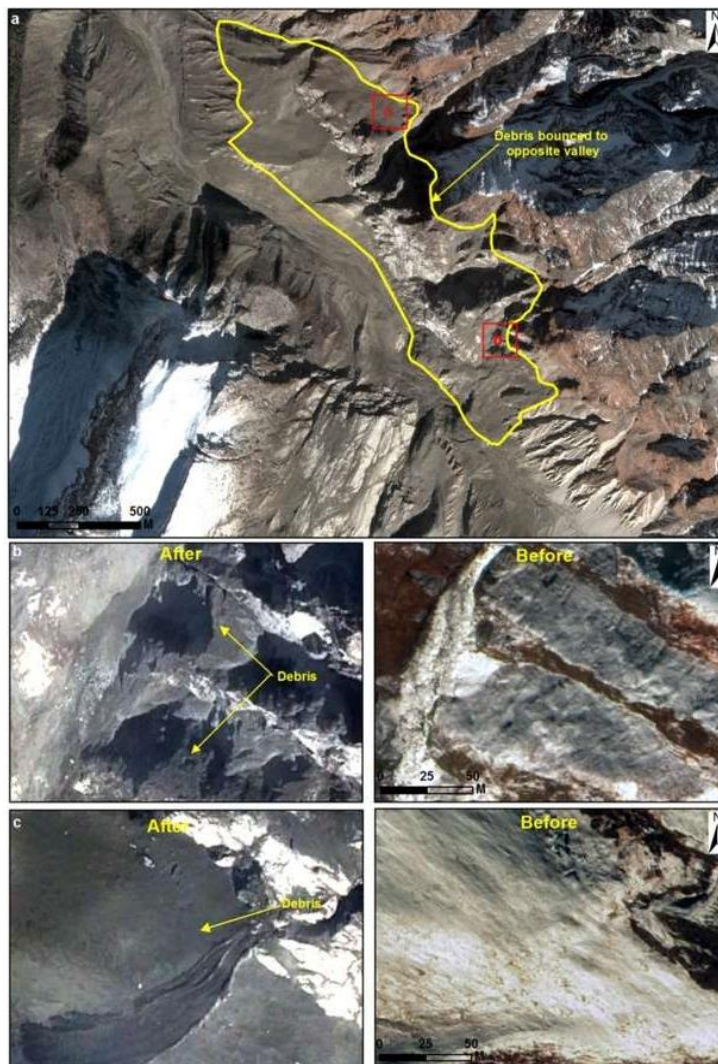
The impact of rock and ice that crashed to the valley floor was so high that the pulverised rock mass and boulders have over-ridden on the mountain opposite the valley. Satellite data interpretation shows debris and boulders lying at an altitude of 4015m which is approx. 285m above the valley floor (Figures 18 and 19).

**Figure 19:**a. Zone of debris deposition on the opposite valley shown over the post-event Pleiades image. b. and c. show after and before images of debris deposition

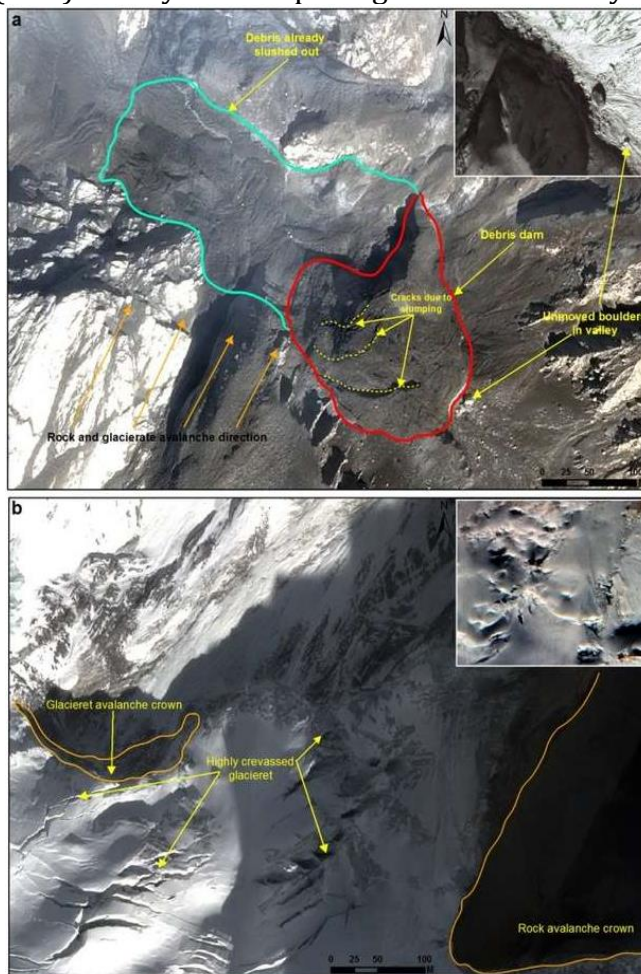
The mass of rock and ice that fell on the Raunthi Gadhera valley was pulverised due to its high impact. The debris was strewn all over the crash zone and to the opposite valley wall. A large heap of debris was mainly deposited on the valley floor. It is seen from the satellite data interpretation that the debris deposited in the valley was removed partially on 7<sup>th</sup> February 2021. Still, a large chunk of debris is lying in the valley. This has blocked the valley completely by creating a landslide dam. Minor accumulation of snowmelt water on the upstream side is already visible in the image (Figure 20). Since snowmelt is expected to increase during the summer, water will further accumulate due to blockage of flow by the debris dam. The debris dam is unstable and cracks are visible due to slumping. We have evaluated the stability of the dam using two indices i.e., Morphological Obstruction Index (MOI) and Hydro-morphological Dam Stability Index (HDSI).

**Figure 20:** Two potential hazard zones in the Raunthi Gadhera valley mapped using Pleiades image. a. Pulverised chunk of debris blocking the valley. The red polygon shows the extent of the landslide debris that has blocked the Raunthi Gadhera valley. b. Highly crevassed glacieret west of the crown of the rock avalanche. Insets show the pre-event high-resolution image of Komsat-3A.

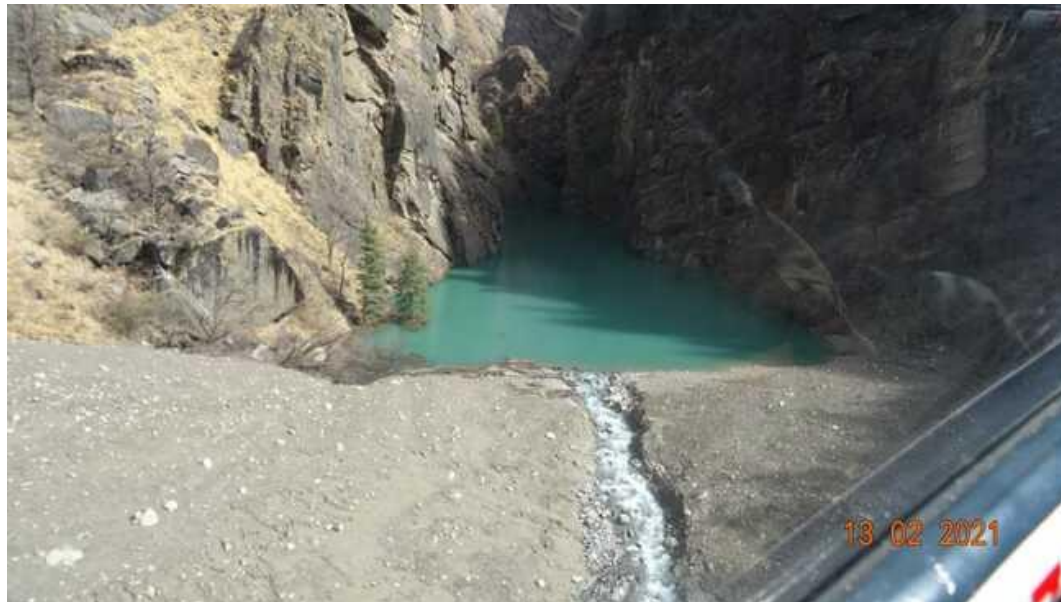
The huge debris deposit of Raunthi Gadhera debris flow at Rishiganga confluence blocked the flow of the Rishiganga River resulting in the formation of an artificial lake due to damming by debris material. The site photograph of the lake and blockage is shown in Photo 7.

**Photo Plate 7:** Site photograph of the lake formed due to debris blockage of Rishiganga river
