## DETAILED REPORT

### Study of Causes & Impacts of the Uttarakhand Disaster on 7<sup>th</sup> February 2021 in Raunthi Gadhera, Rishiganga & Dhauliganga Valley: Measures to Reduce Disaster Risks

April 2022

**NATIONAL DISASTER MANAGEMENT AUTHORITY  
MINISTRY OF HOME AFFAIRS  
GOVERNMENT OF INDIA**

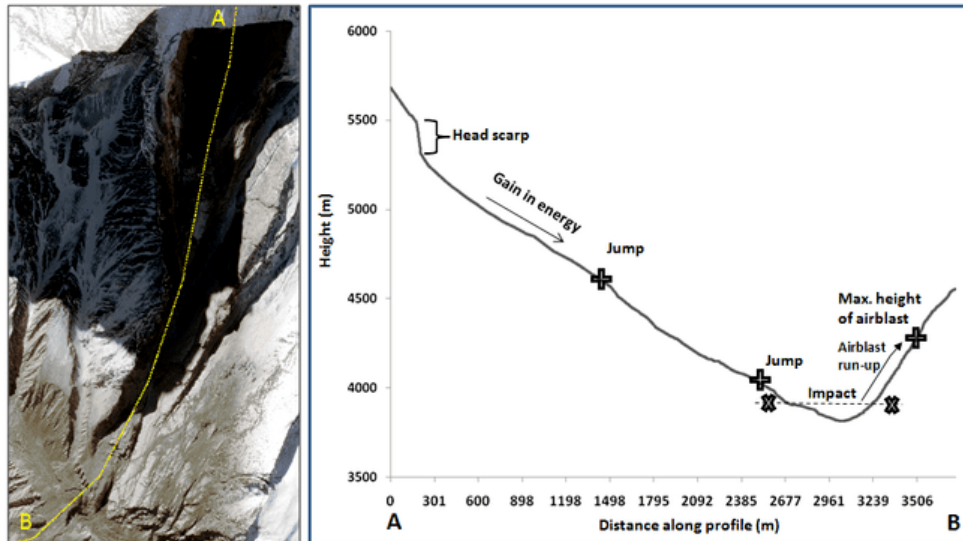
The impact of rock and ice that crashed to the valley floor was so high that the pulverised rock mass and boulders have over-ridden on the mountain opposite the valley. Satellite data interpretation shows debris and boulders lying at an altitude of 4015m which is approx. 285m above the valley floor (Figures 18 and 19).

**Figure 18:** Elevation profile along the travel path showing behaviour of the Rock avalanche

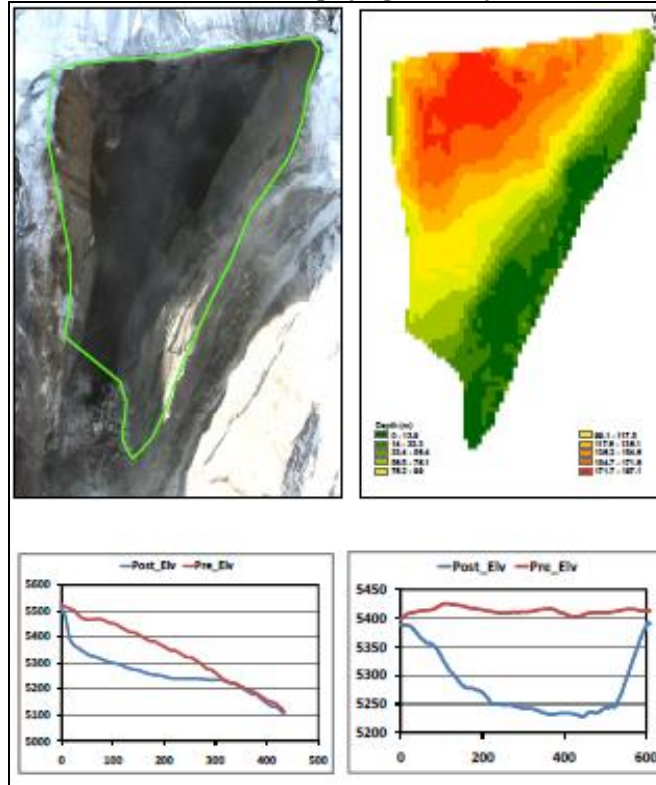
The release area i.e. the rock and ice mass detached from the crown was identified by photo-geological interpretation of the stereoscopic Pleiades images. Cut and fill analysis within the release area carried out using pre-and post-disaster DEMs estimated the volume of the landslide as ~29.3 million m<sup>3</sup>. The height of the release area was estimated by DEM differencing and the maximum height (~197 m) of the release area was found near the head scarp (Figure 21).

**Figure 21:** Depth map of dislodged rock and ice estimated using DEM analysis. Longitudinal and transverse elevation profiles derived from Pre- and post-DEM are also shown

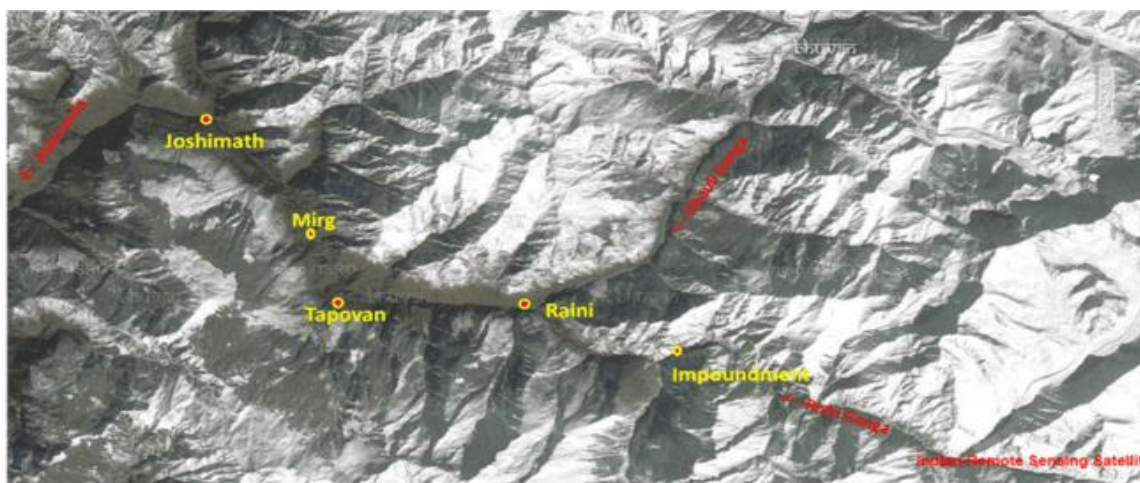
The debris dammed lake is formed due to sediment obstruction after the major debris flow event that occurred on 7<sup>th</sup> February 2021. It is reported that water impoundment is taking place at latitude 30° 27' 59.24" N and longitude 79° 43' 57.7" E in the Rishiganga Catchment as shown in Figure 22. When the water level rises on U/S of the obstruction there is a possibility of overtopping or breach in the obstructions due to water pressure.

**Figure 22:** Topographic description of the study area (with impoundment location)

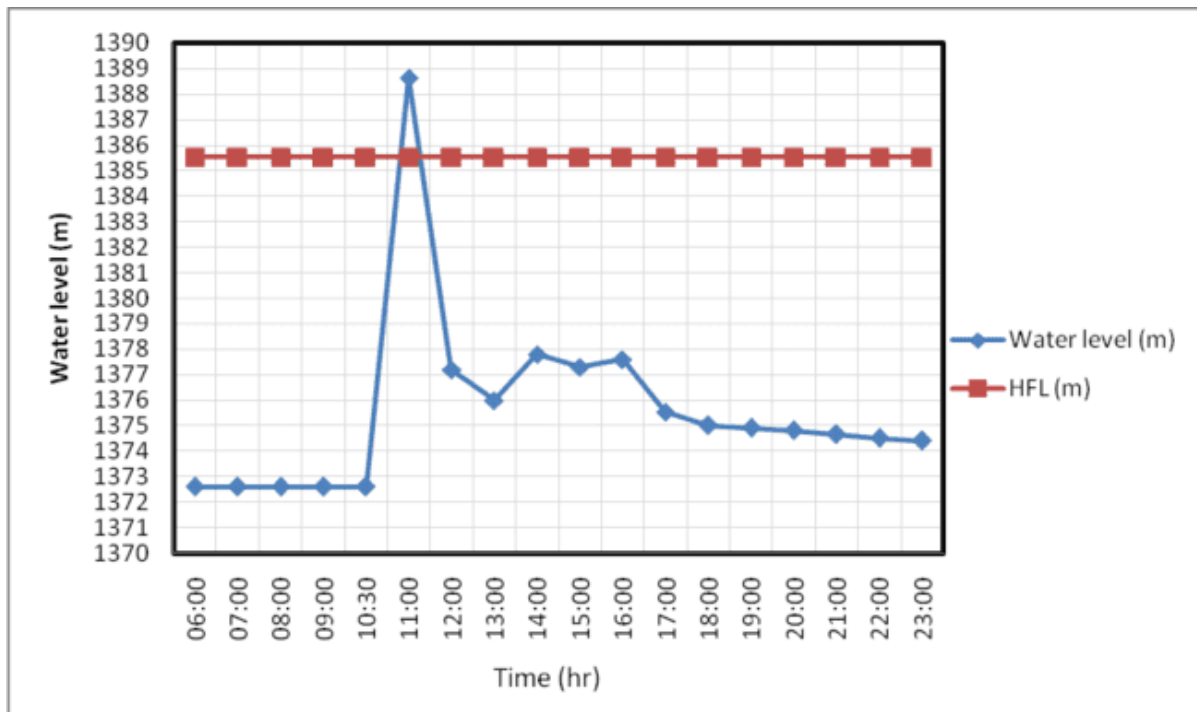
At the CWC G&D site of Joshimath, the highest observed flood level (HFL) before this debris flow even was at EL 1385.54 m. On 7<sup>th</sup> February 2021, the observed flood level at 11:00 AM due to debris flow was 1388.65 m, which was above 3.11 m above the HFL. It may be noted that due to backflow of debris flow in Rishiganga, Dhauliganga, and Alaknanda rivers and deposition of huge sediment at Raini, Rishiganga, Dhauliganga, and at Tapovan project site, the debris flow peak reached CWC G&D site is a highly attenuated flood peak. The observed water level on 07<sup>th</sup> February 2021 at Joshimath G&D site of CWC is given in Figure 24.

**Figure 24:** Observed water level on 7<sup>th</sup> February 2021 at Joshimath G&D site of CWC (Source: CWC)

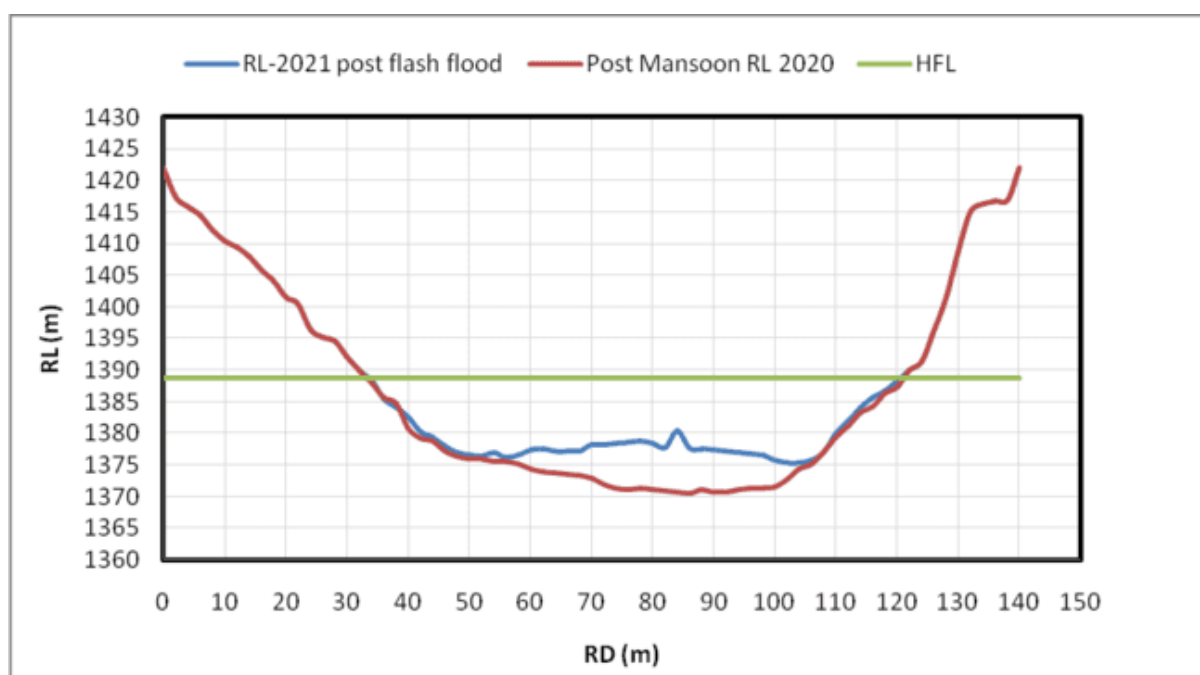
CWC has also provided the surveyed river cross-sections of the Joshimath G&D site post-monsoon 2020 and after the event of 7<sup>th</sup> February 2021. From the cross-section data, it has been found that the sediment deposition due to debris flow has resulted in maximum deposition of about 7 m at the deepest bed level point of Alaknanda at the G&D site. The average sediment deposition at the above location is about 3 m. The plot of the Alaknanda river cross-section at Joshimath G&D site is given in Figure 25.

**Figure 25:** Plot of Alaknanda river cross-section at Joshimath G&D site of CWC in pre and post flash flood scenario

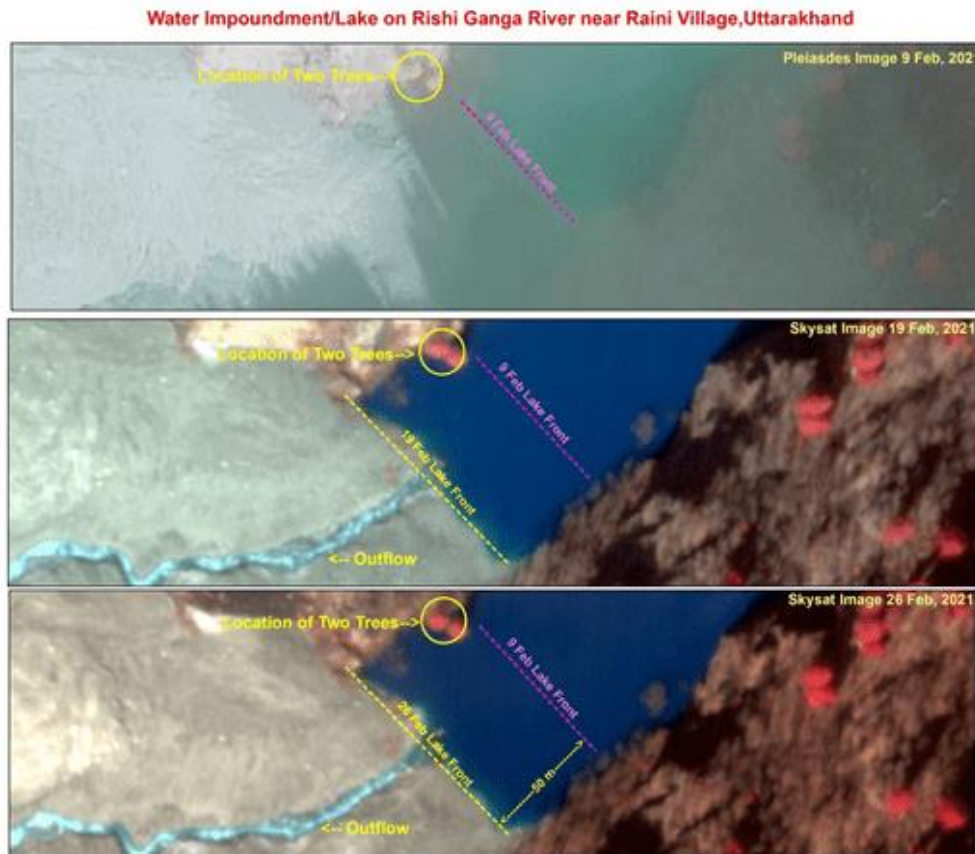
**Figure 26:** Time series of satellite imagery showing lake monitoring status  
(Source: NRSC-ISRO)

From the time series analysis of satellite data, it has been found that the lake front has moved about 50m forward when satellite data of 26<sup>th</sup> February was compared with 9<sup>th</sup> February 2021. As the lake water level reached the highest level of sediment deposits, it is found that the lake started overflowing. Breach width is found to be widened marginally. As the inflow to the lake is going as an outflow, there is no significant increase is found in lake volume and area.

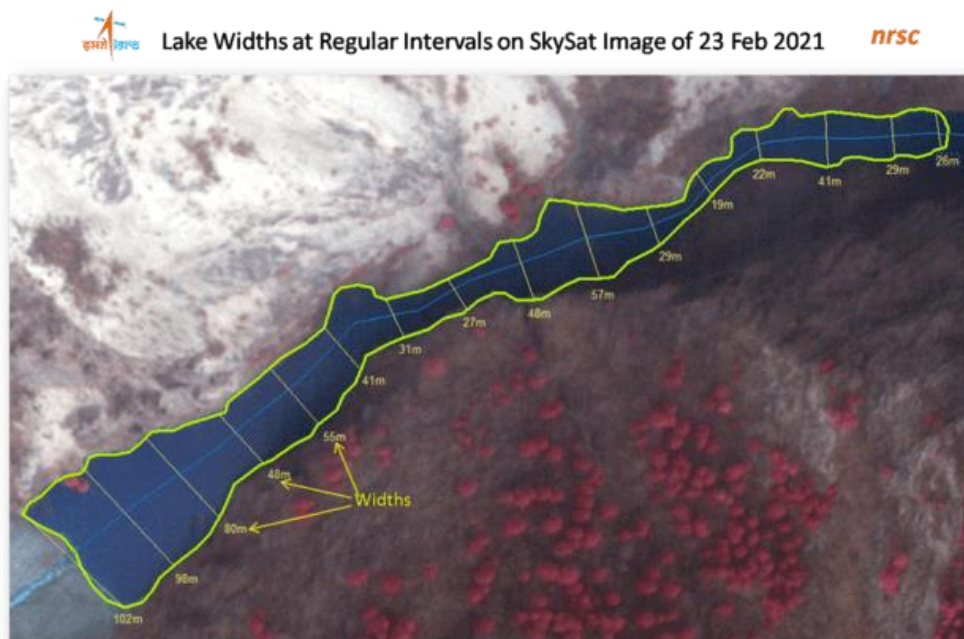
Lake widths were measured at 50m intervals along the river using satellite data of SkySat 4 of 23<sup>rd</sup> February 2021 (0.5 m resolution) and shown in Figure 27. Lake depth information provided by the Indian Navy was further analysed and interpolated at required locations and shown in Figure 28. Lake cross-sectional areas at all locations (50m interval) were computed. The bottom width of the river was measured/computed using pre-satellite data and DEM. Lake volume was estimated using the Prismoidal formula. A possible flood discharge scenario has been generated using Froehlich Method using these

**Figure 27:** Width of the River at Different Locations (SkySat 23<sup>rd</sup> February 2021 Image)  
(Source: NRSC-ISRO)

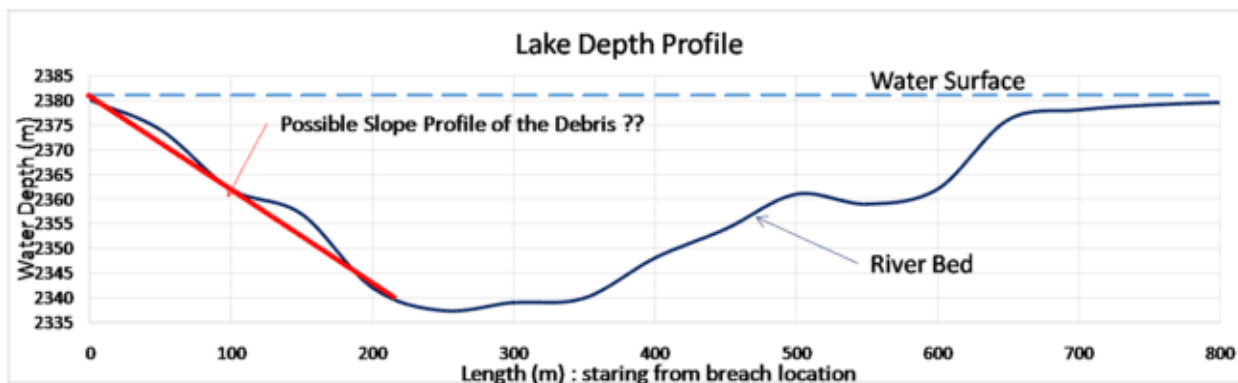
**Figure 28:** Water Depth in the River Rishiganga at Debris Dam block site  
(Source: Indian Navy)

Lake water-spread area is found to be 3.69 hectares

Lake volume is found to be 0.49 MCM

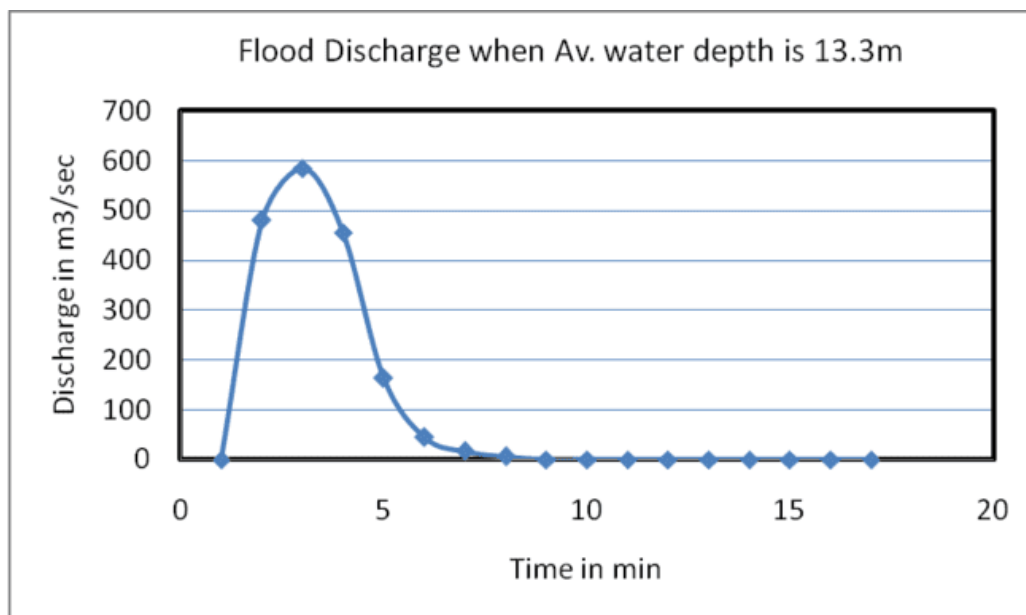
**Figure 29:** Flood Hydrograph when the peak discharge is 585  $m^3/sec$

In this method, depth of flow, width, and length of water impoundment are the main inputs for computing model parameters like  $Q_p$ ,  $T_p$ . Peak discharge ( $Q_p$ ), time to peak ( $T_p$ ) are calculated using the above equations 1 to 3. Considering the water level above breach as 13.3 m, the breach parameters are computed using the above equations, and the computed peak discharge is found to be approximately 585  $m^3/sec$  in case of sudden failure of the dam, and computed flood hydrograph is shown in Figure 29.

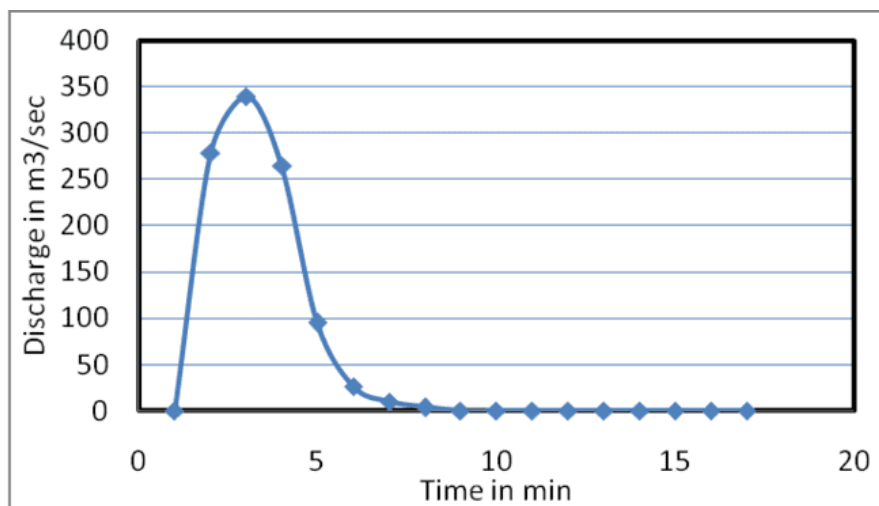
**Figure 30:** Flood Hydrograph when the peak discharge is 340 m<sup>3</sup>/sec

NWS DAMBRK method is popular for computing scenarios due to the gradual failure of the dam. The scenarios are evaluated in the MIKE software environment for which the same breach parameters computed above equations. Peak discharge estimated using MIKE11 is 340  $m^3/sec$  shown in Figure 30.

Out of the above two scenarios analysed, scenario two is the more probable scenario considering the blockage width, length, height, etc.

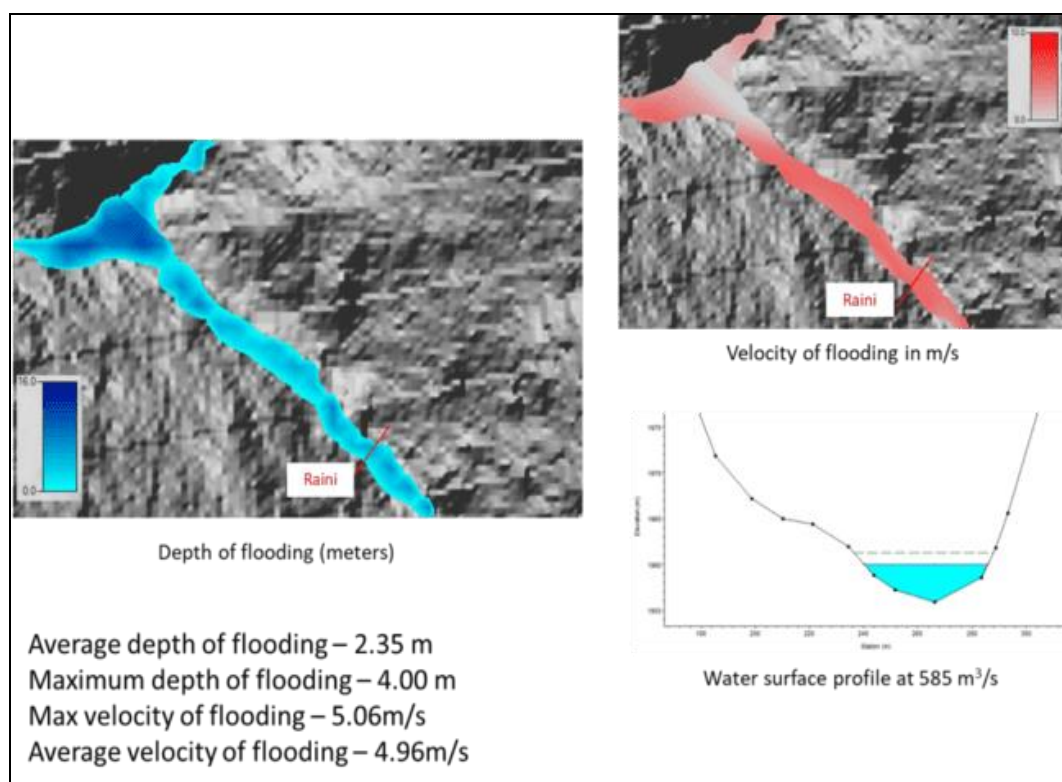
**Figure 31:** Flood inundation simulations at Raini for peak discharge of 585 m<sup>3</sup>/sec  
(Source: NRSC-ISRO)

Flood inundation simulations are computed for the worst possible conditions (for sudden breach flood discharge) to assess the depth of flooding, the extent of flooding, and the velocity of flow when the peak discharge is 585m<sup>3</sup>/sec. Simulation results at Raini and Tapovan are shown in Figures 31 and 32 respectively. The average depth of flooding was found to vary from 2 to 8.8 m and the maximum velocity of flooding is found to vary from 5.1 to 1.6 m/sec at Raini and Tapovan locations.
